Field and Numerical Study for Deteriorating Precast Double-Tee Girder Bridges

FIELD AND NUMERICAL STUDY FOR DETERIORATING PRECAST
DOUBLE-TEE GIRDER BRIDGES

Master of Science

Major in Civil Engineering

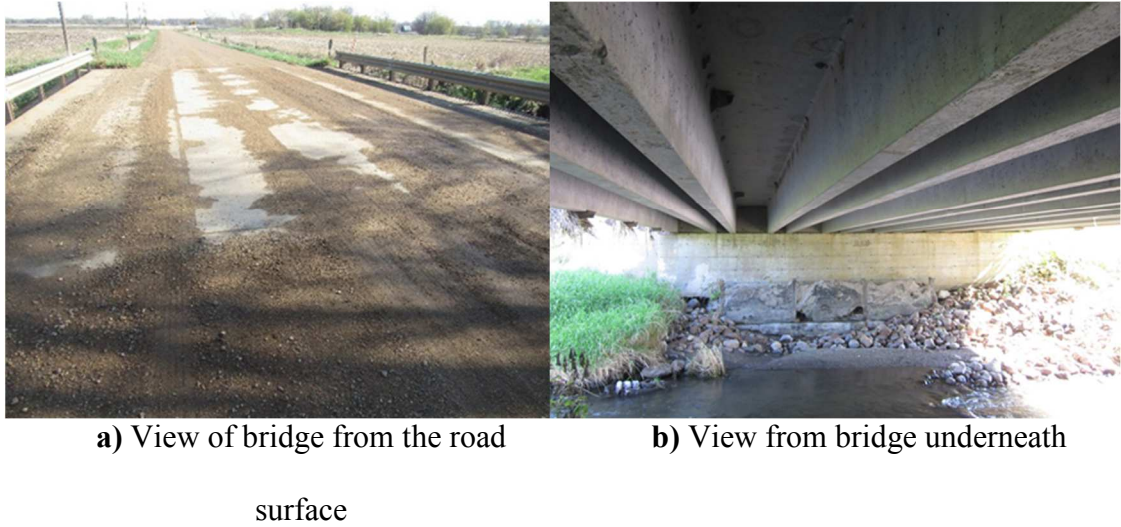
FIGURE 1. Description of 762-mm Deep DTG Bridge

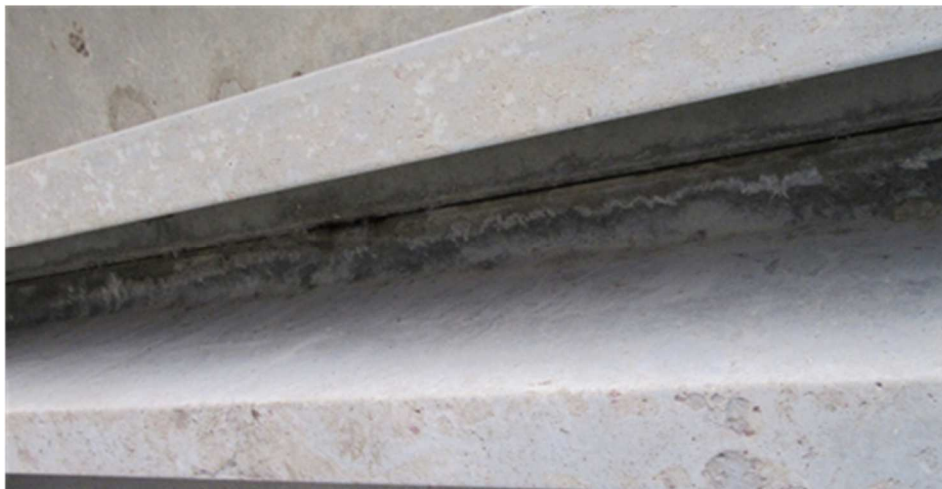
FIGURE 3. Example of Efflorescence on 762-mm Deep DTG Bridge

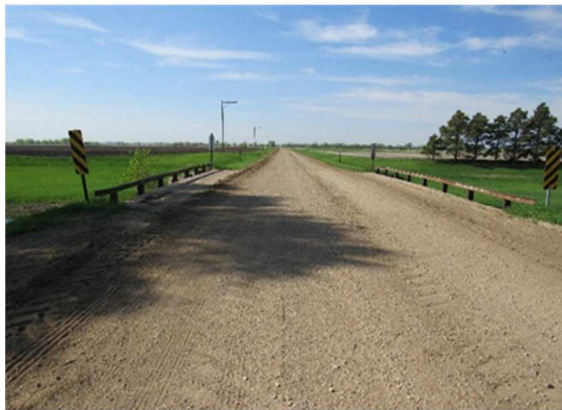
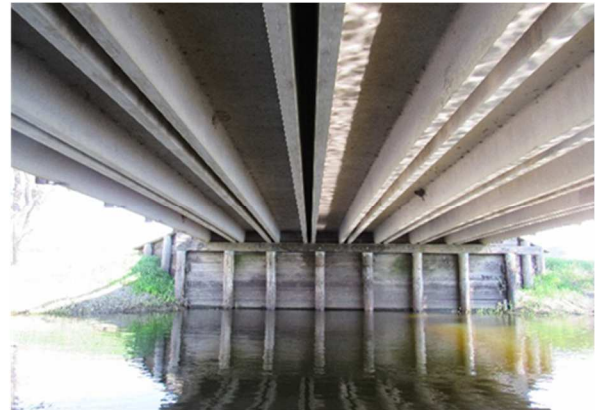
FIGURE 4. Description of 584-mm Deep DTG Bridge

The second field testing was performed on another single-span, prestressed DTG bridge but incorporating eight 584-mm deep girders. The bridge span length was 15.24 m, and the bridge was simply supported on timber abutments, with no skew angle. At the time of testing, this bridge had been in-service for 38 years in Moody County in South Dakota. This is one of the standard DTG sections used in South Dakota DTG bridges. The cross section is shown later in this paper. The bridge has a gravel wearing surface. Each girder was 1.17-m wide connected to the adjacent girder using a steel-plate connection and grouted joint. Figure 4 shows the road surface and a view from the bridge underneath. A visual inspection was conducted before the field tests, and Fig. 5 shows the observed damage including the efflorescence and water leakage in the girder-to-girder joints. An example of the leakage is shown in Figure 6.

a) View of bridge from road surface

b) View from bridge underneath

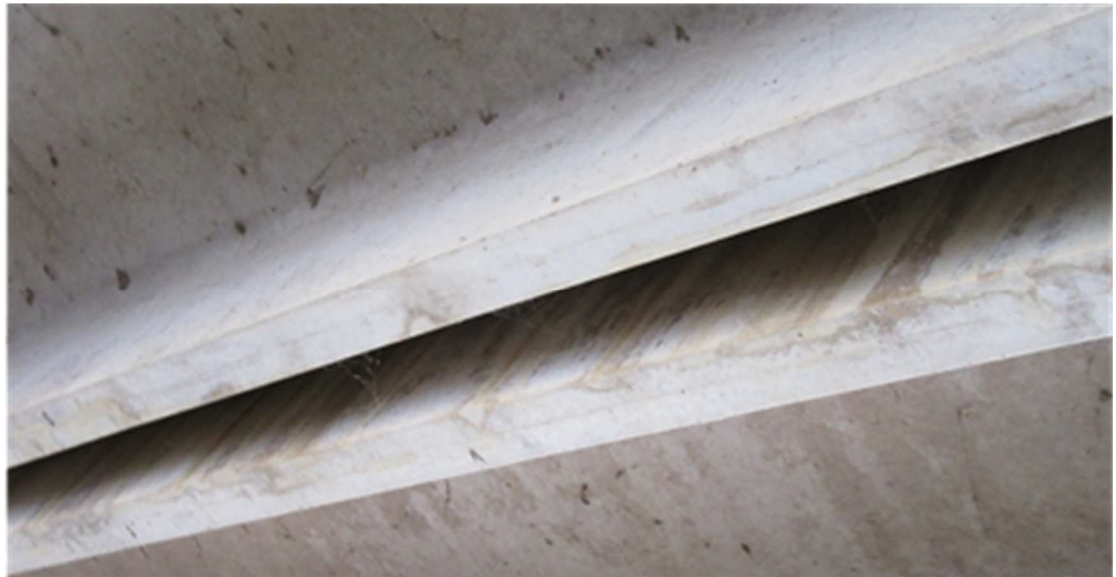
FIGURE 6. Example of Efflorescence on 584-mm Deep DTG Bridge

girders (Fig. 5). For example, Fig. 6 shows the condition of the longitudinal between girders G4 and G5 for this bridge.

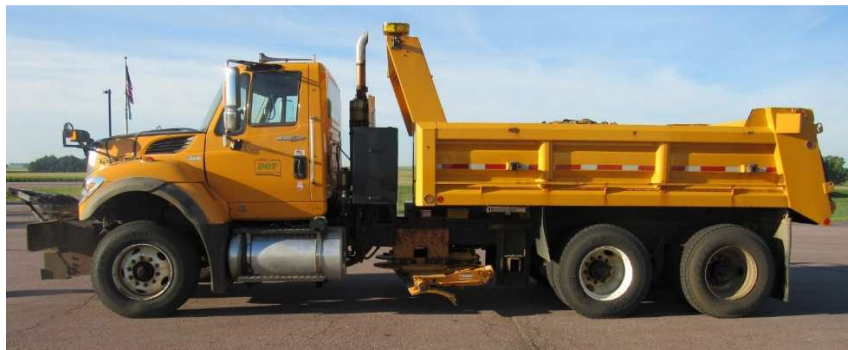
FIGURE 7. South Dakota Legal Load Type 3 Truck used for Field Testing

As shown in Figure 7, the truck used for all the field tests was a South Dakota Legal Type 3 Truck. The truck weighed 222 kN, with a front axle weight of 74.6 kN and a combined weight of 147.7 kN for the rear two axles. The weight per each rear axle was not measured. The axle configuration can be seen in Figure 8. The distance between the first and second axle was 4.97 m. The distance between the rear two axles was approximately 1.5 m.

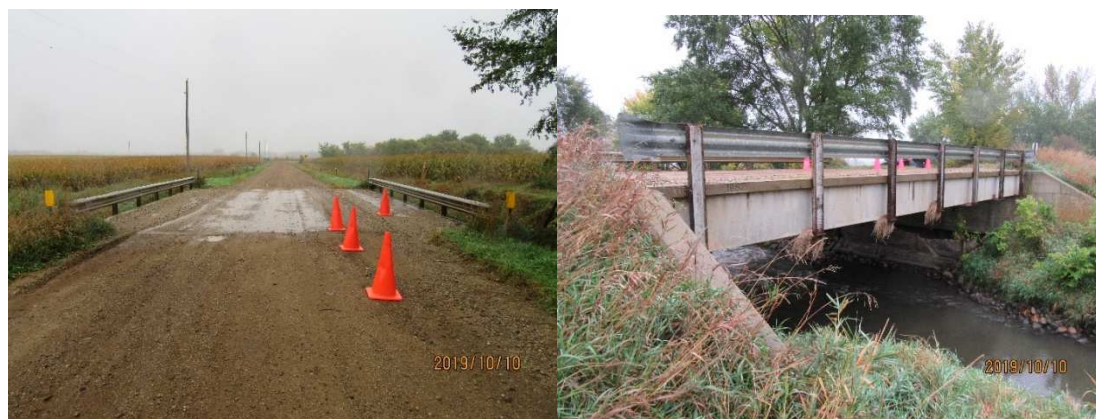
Figure 1. Pictures of Bridge A (Credit: Dr. Junwon Seo)

The first bridge tested is a 34 year old DT girder bridge on a gravel road. The girders are 762-mm deep, 1.2 meters in width, and contain four prestressing strands per stem. The bridge is simply supported with a single span length of 11.6 meters. The girders bear on concrete abutments and are connected by grout with steel shear plates at a spacing of 1.5 meters. The bridge consists of seven DT girders with no skew angle. Figures 1a and 1b show pictures of the bridge, taken before testing. Leakage through the joint, efflorescence, and corrosion from the steel plates has been identified at multiple locations on nearly every longitudinal joint. Locations of the damage are shown in Figure 2. An example of the damage can be seen in Figure 3.

a) Surface

b) Side View

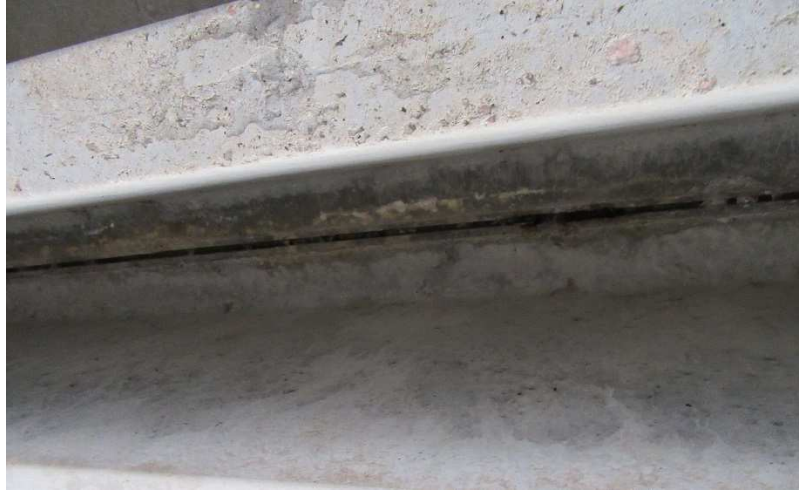
Figure 3. Efflorescence and Erosion between G7 and G6 on Bridge A (Credit: Brian Kidd)

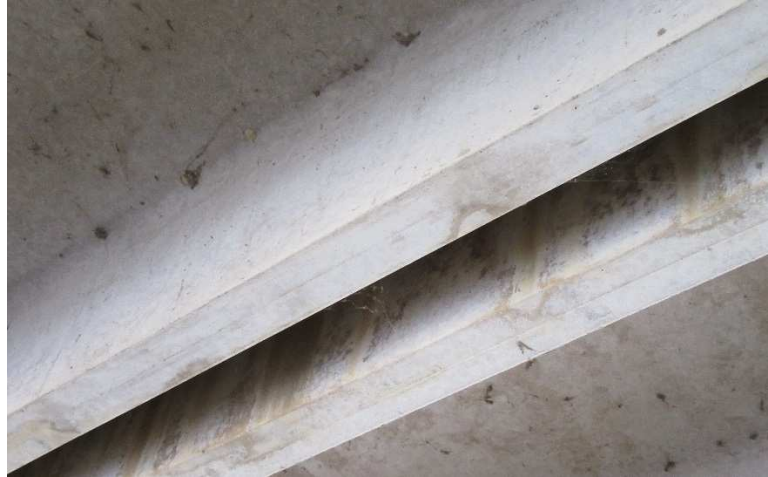
Figure 6. Example of Staining on the Bridge B (Kidd et al. 2020)

The second bridge tested has been in-service for 38 years. There are eight DT girders connected by grout and a shear plate every 1.5 meters. Each girder is approximately 1.2 meters in width, 584-mm deep, and contains seven prestressing tendons per stem. The bridge is simply supported with a single span of 14.6 meters. The girders bear on timber abutments. Pictures of the bridge can be seen in Figures 4a and 4b. A visual inspection of the bridge was performed before the field tests, and a map of the joint damage was created. Figure 5 shows the damage on the bridge. Leakage through the joints, efflorescence, and corrosion of the shear plates were observed in the joints between the DT girders. An example of the joint damage is shown in Figure 6. Notice the efflorescence and leakage (staining) between the stems of adjacent girders.

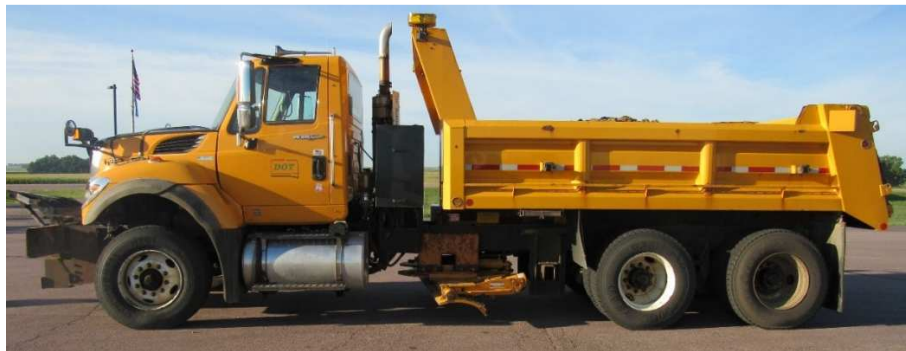
Figure 9. Truck used for Field Testing (Kidd et al. 2020)

A truck matching the SD Legal Load Type 3 was driven across the bridges at a speed of 8 km/hr, to represent a crawl speed loading. A picture of the test truck is shown in Figure 9a. The total weight of the truck was 222.32 kN. The weight distribution between axles is shown in Figure 9b. The axle with was approximately 2.2 meters. More information about field testing can be found in Kidd et al. (2020).

a) Side View

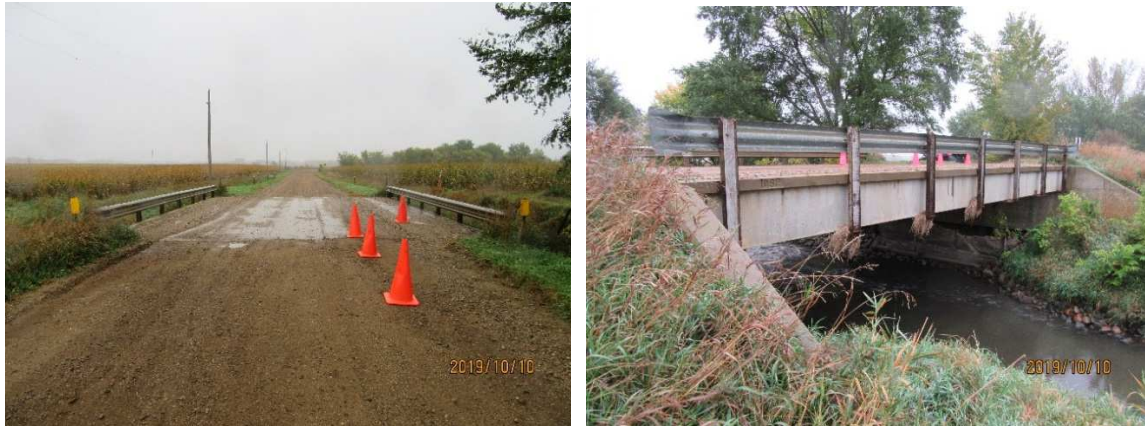
Figure 1. Pictures of the DT Bridge Tested

The first DT girder bridge selected for this study is 34 years old and is in-service on a gravel road in Lincoln County, South Dakota. The bridge consists of seven prestressed, DT girders bearing on concrete abutments. The girders are 762 mm deep, with a 127 mm deep top flange, and have a span length of 11.6 meters. The longitudinal joints have a welded steel plate connection spaced every 1.52 meters and then filled with grout (Bohn 2017). Figure 1 shows a picture of the bridge. The cross section of one DT girder is shown in Figure 2. Significant damage of the longitudinal joints between girders was present and the damage is discussed later in this study.

a) Road Surface

b) Side View

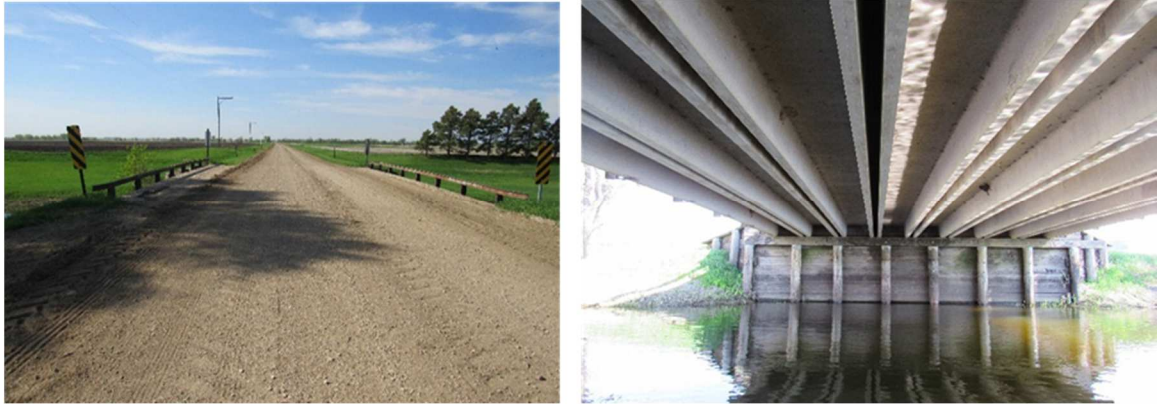
Figure 3. Description of 584-mm Deep DTG Bridge

The second DT girder bridge selected for this study is 38 years old and is in-service on a gravel road in Moody County, South Dakota. The bridge has seven prestressed, DT girders that bear on timber abutments. The girders are 584 mm deep, with a 127 mm deep top flange, and a span length of 14.6 meters. The longitudinal joints are a steel shear key with grout, similar to Bridge A. Figure 3 shows pictures of the bridge and the cross section can be seen in Figure 4. Significant longitudinal joint damage is present on this bridge and will be discussed in more detail later in this paper. It is also important to note that G4 had a shear crack near the north abutment.

a) View of bridge from road surface

b) View from bridge underneath

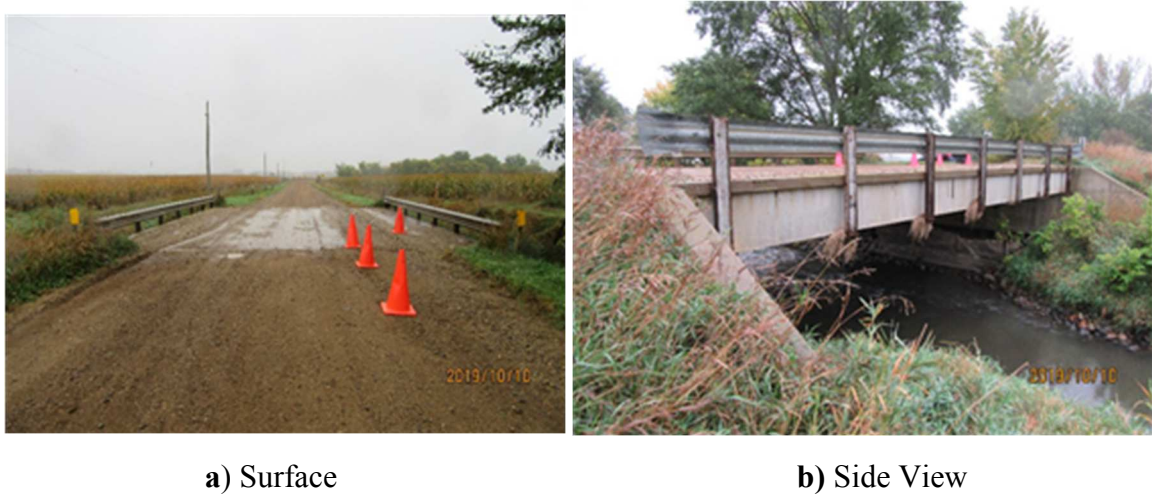
Figure 1. Pictures of Bridge A

The first DT girder bridge tested was 34 years old and had seven prestressed, DT girders. The girders are 762 mm deep and the span length is 11.6 meters. The DT girders are supported by concrete abutments with no skew angle. The wearing surface of the bridge is gravel. The girders are connected using a steel plate and grout connection. The

steel plates are placed every 1.2 meters along the longitudinal joints. Pictures of the bridge are shown in Figures 1a and 1b.

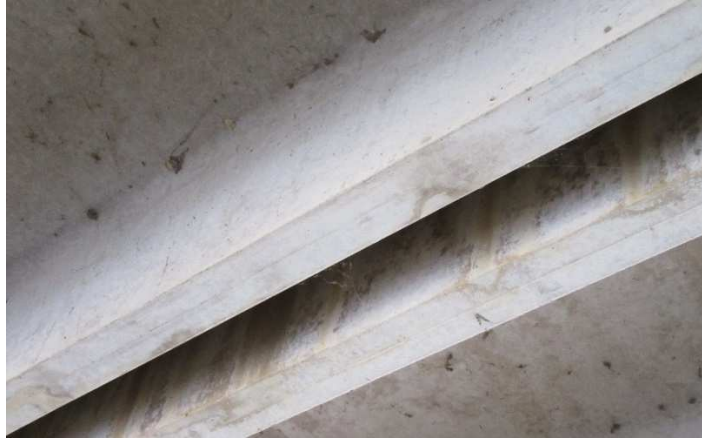
Figure 7. Example of Staining on Bridge B

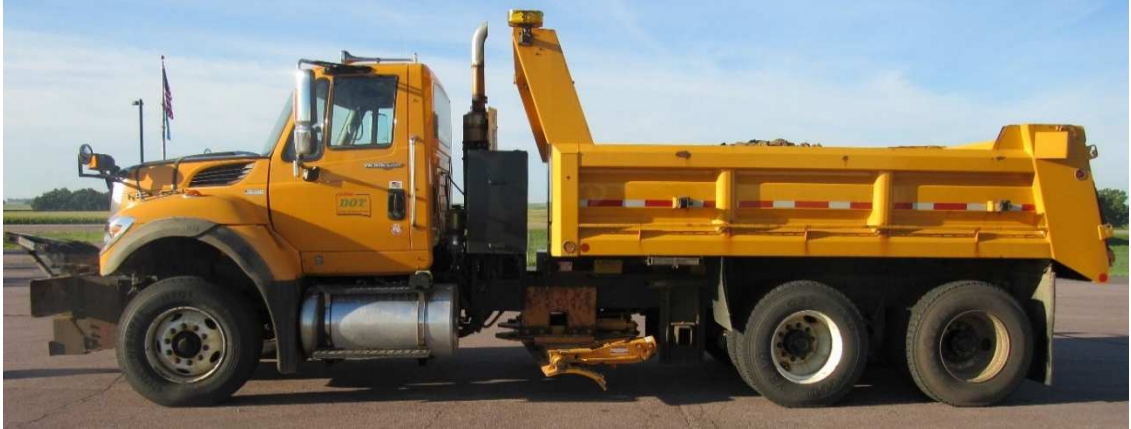
Figure 9. Truck Used for Field Testing of Bridges A and B

The DT bridge was tested using a crawl speed load to determine the strain of the girders. The goal of the tests was to determine the flexural LLDFs of the DT girders. A truck that weighed 222 kN was used for the field tests. The truck is shown in Figure 9 and the axle configuration of the test truck can be seen in Figure 10.
